TECHNICAL NOTE 2812

EFFECTS OF CYCLIC LOADING ON MECHANICAL BEHAVIOR
OF 24S-T4 AND 75S-T6 ALUMINUM ALLOYS
AND SAE 4130 STEEL

By C. W. MacGregor and N. Grossman
Massachusetts Institute of Technology

October 1952

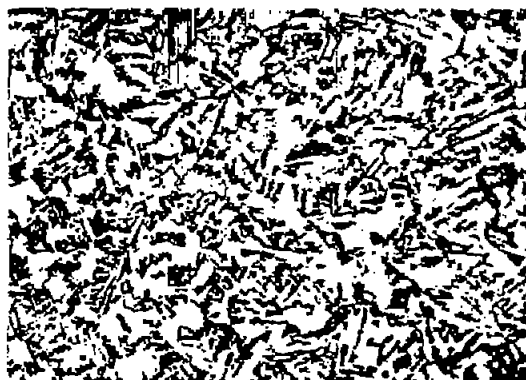
Figure 1.- Photomicrographs of SAE 4130 steel tested.

(a) Transverse. X100.

(b) Longitudinal. X100.

(c) Transverse. X500.

(d) Longitudinal. X500.

Two commercial aluminum alloys (24S-T4 and 75S-T6) and an aircraft quality alloy steel (SAE 4130) were used in the present investigation. The rods were obtained in 1/2-inch-diameter stock from the Aluminum Company of America and the Carnegie-Illinois Steel Corp., respectively. Table I lists the chemical analyses and mechanical properties; figures 1 and 2 show the photomicrographs.

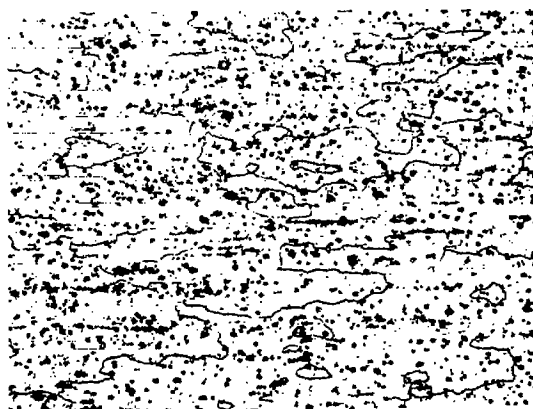
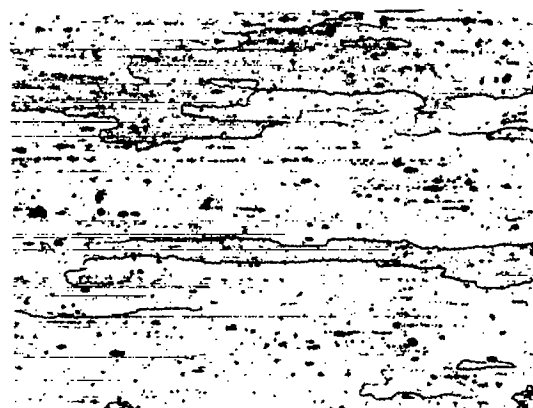
Figure 2.- Photomicrographs of aluminum alloys tested. X100.

(a) 24S-T4 aluminum alloy as received.

(b) 75S-T6 aluminum alloy as received.

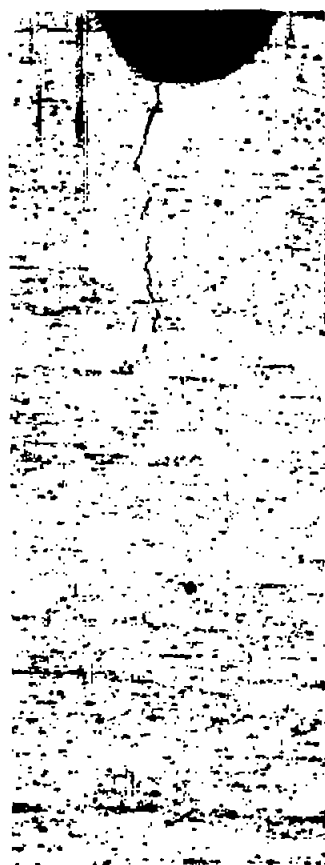
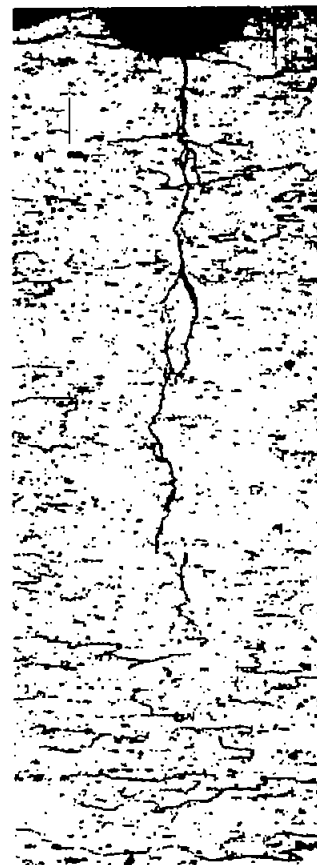
(a) SAE 4130 steel; nominal fatigue bending stress, 33,000 psi.

Figure 8.- Longitudinal sections of V-notched specimens showing cracks after various numbers of cycles of fatigue stressing. Notch, 1/16 inch deep with 0.01-inch radius.

(b) 24S-T4 aluminum alloy; nominal fatigue bending stress, 13,000 psi.

(c) 75S-T6 aluminum alloy; nominal fatigue bending stress, 15,000 psi.

It was deemed important, therefore, to determine whether this was a peculiarity of mild steel or whether this phenomenon occurred in other metals as well. Consequently, crack studies were made of specimens subjected to prior fatigue cycles for all three of the metals discussed here for stresses below and above the endurance limits. The technique used was described earlier under "Testing Procedure." Figures 8 to 10 show typical longitudinal sections revealing fatigue cracks for the three metals stressed above the notched endurance limit for different numbers of cycles. Figures 8(a) to 8(c) are for V-notched specimens; figures 9(a) and 9(b), for U-notched specimens; and figures 10(a) and 10(b), for unnotched bars. This method yielded erratic results because the circumferential cracks which originated at the root of the notch and penetrated radially inward were not necessarily symmetrical about the axis of rotation of the specimens. Thus, it was found satisfactory to photograph the stressed and subsequently fractured specimens which showed two clearly distinguishable areas, an outer ring due to the slowly penetrating cumulative "cracks" and the inner "core" which was suddenly fractured. Figures 11

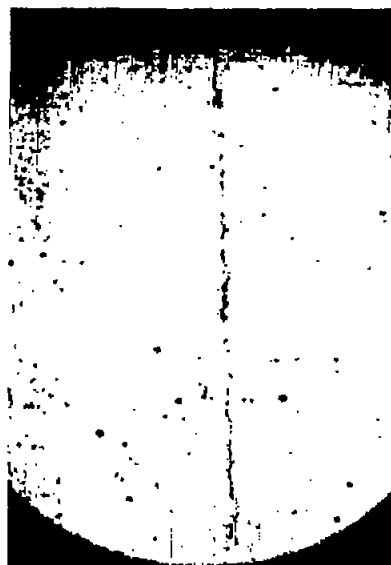
(a) SAE 4130 steel; nominal fatigue bending stress, 60,000 psi.

Figure 10.- Longitudinal sections of unnotched specimens showing cracks after various numbers of cycles of fatigue stressing.

(b) 24S-T4 aluminum alloy; nominal fatigue bending stress, 37,000 psi.

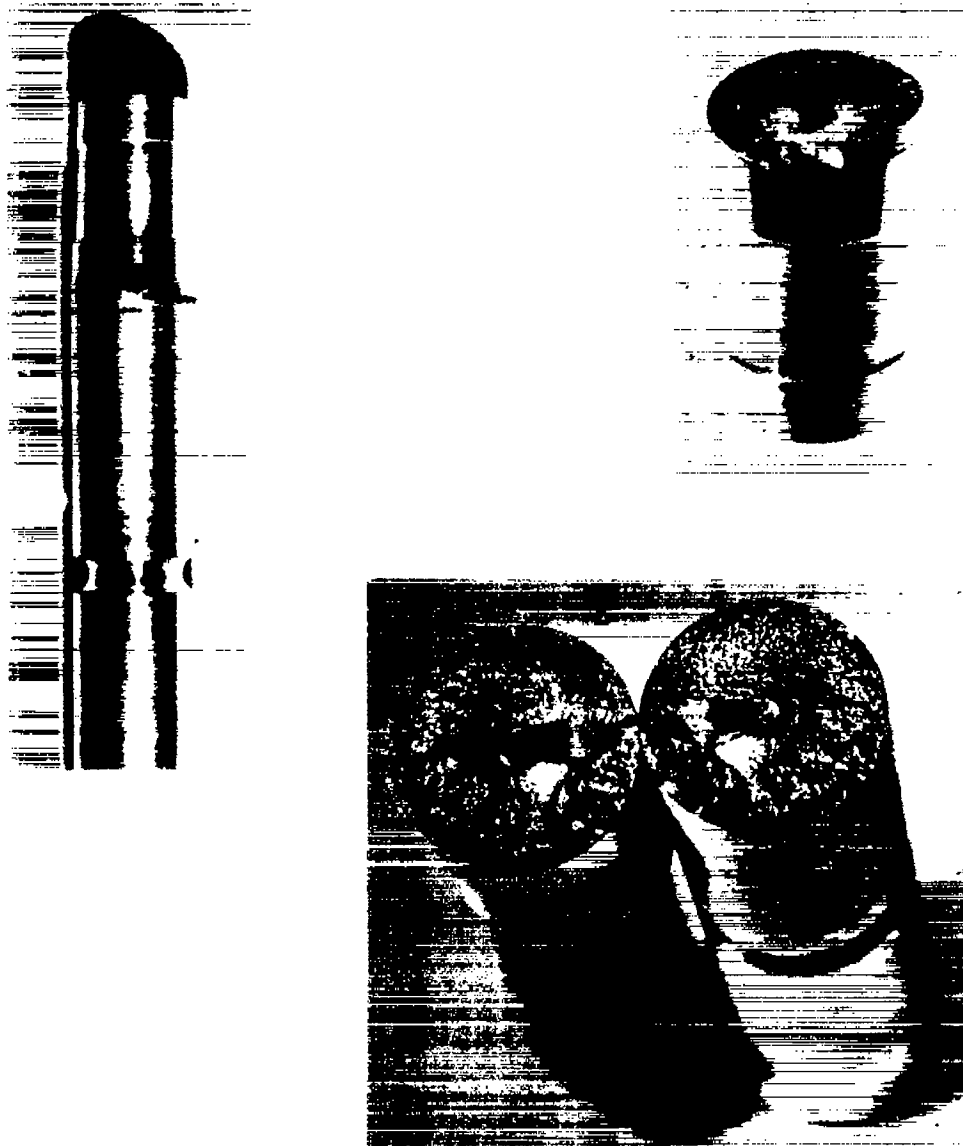
Figure 22.- Views of failure caused by fretting corrosion in chuck for U-notched specimen of 75S-T6 aluminum alloy. Notch, 1/16 inch deep with 1/16-inch radius. Nominal fatigue stress level, 19,000 psi; fracture at 7,700,000 cycles.

Figures 21 to 25 depict typical fretting-corrosion damage on various specimens. Figure 21 shows fretted unnotched specimens of 75S-T6 in the as-received condition where fretting leads to fatigue failure. Figure 22 illustrates a similar failure for a notched specimen of 75S-T6. Figure 23 portrays a 24S-T4 specimen in the as-received condition on which fretting occurred but did not lead to fatigue failure. Figure 24 pictures 24S-T4 specimens artificially aged to approximately the same hardness level as that of the original 75S-T6 material showing fretting corrosion leading to fatigue failure. A 75S-T6 unnotched aluminum specimen, which was heat-treated to reduce its hardness to the level of the 24S-T4 in the as-received condition, fretted in the chuck causing fracture as shown in figure 25.
